THE FEDERATED EMPLOYERS' MUTUAL ASSURANCE COMPANY MVA WORKSHOP

PORT ELIZABETH, 18 SEPTEMBER 2018

MOTOR VEHICLE ACCIDENTS (MVAs) DURING CONSTRUCTION

PROF JOHN SMALLWOOD

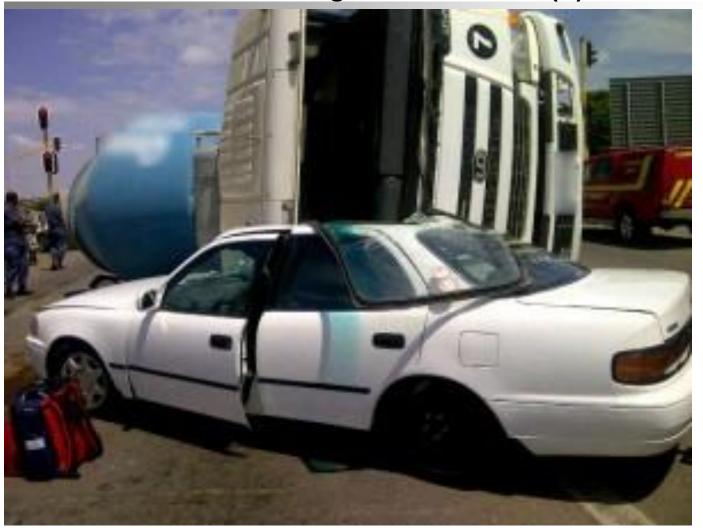
Photo 1: Overturned RMC Truck, Garsfontein Road, 14 November 2012 (Eye Witness News)

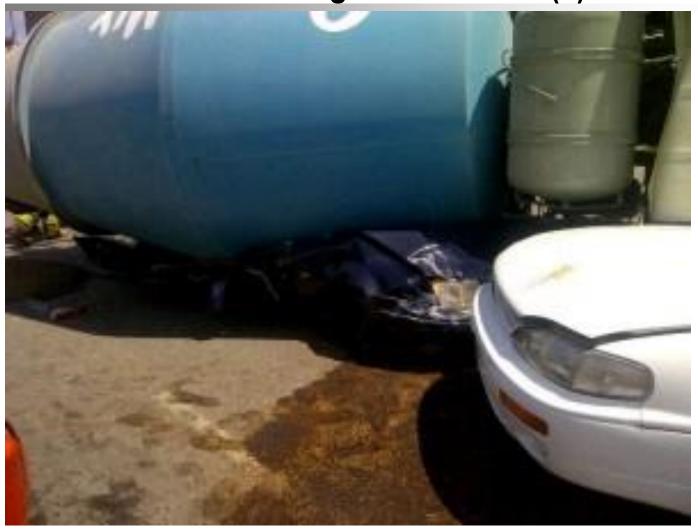
Photo 2: Overturned RMC Truck, Garsfontein Road, 14 November 2012 (Eye Witness News)

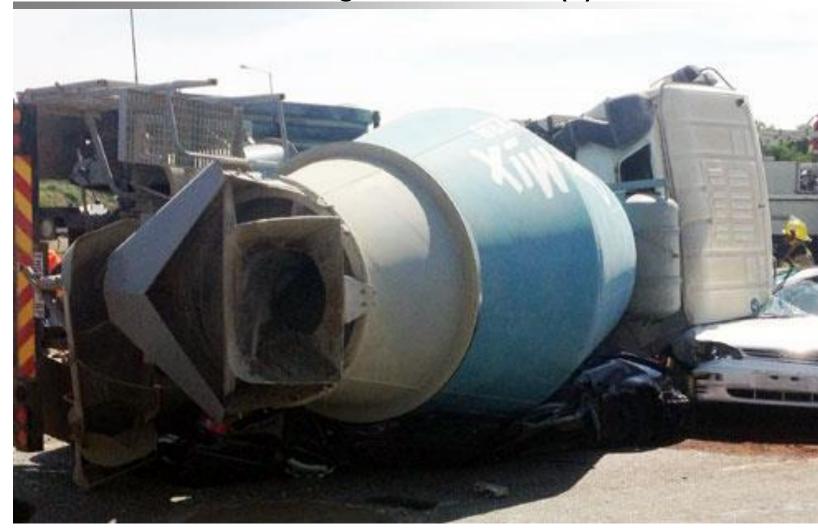
Photo 3: Overturned RMC Truck, Garsfontein Road, 14 November 2012 (Eye Witness News)

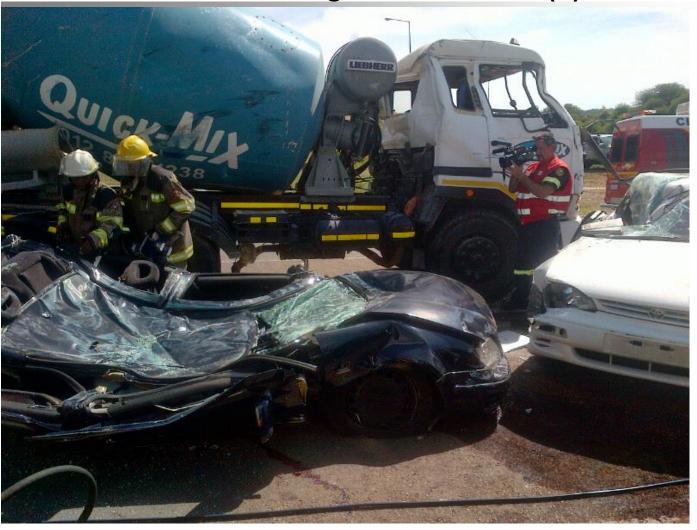
Photo 4: Overturned RMC Truck, Garsfontein Road, 14 November 2012 (Eye Witness News)

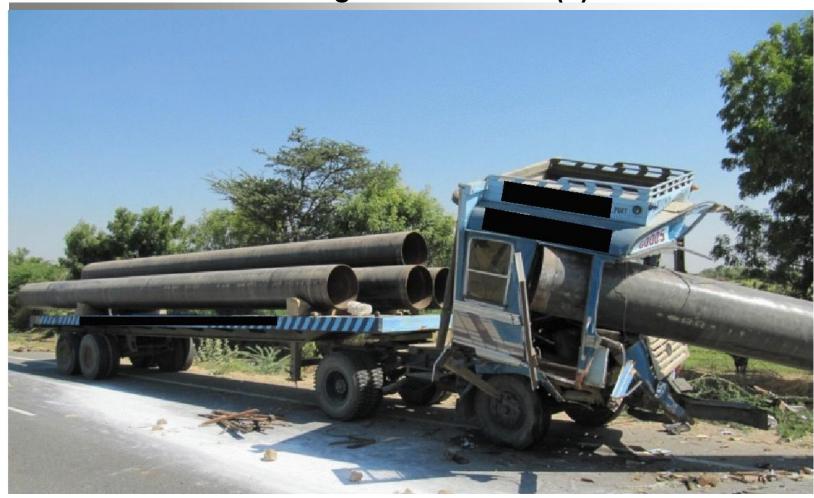
Photo 5: Non-secured load fatality, Oudshoorn, 25 April 2012 (buildsafe, 2012)

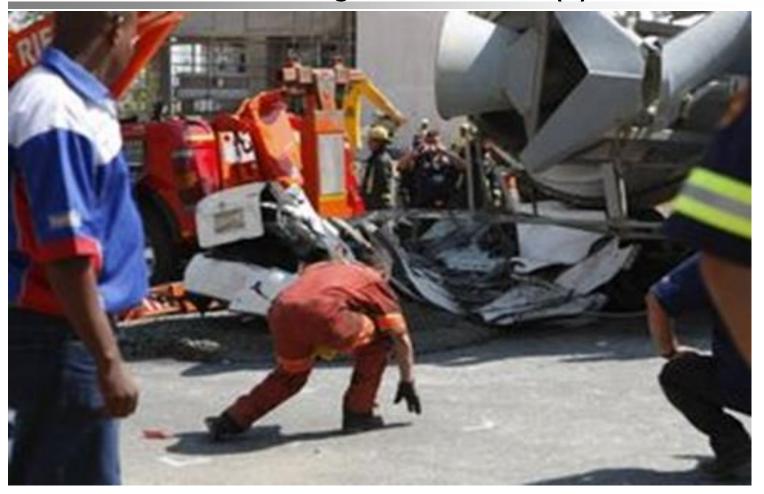
Photo 6: Rescue workers start to free a car trapped under a RMC truck (La Grange, 2009)

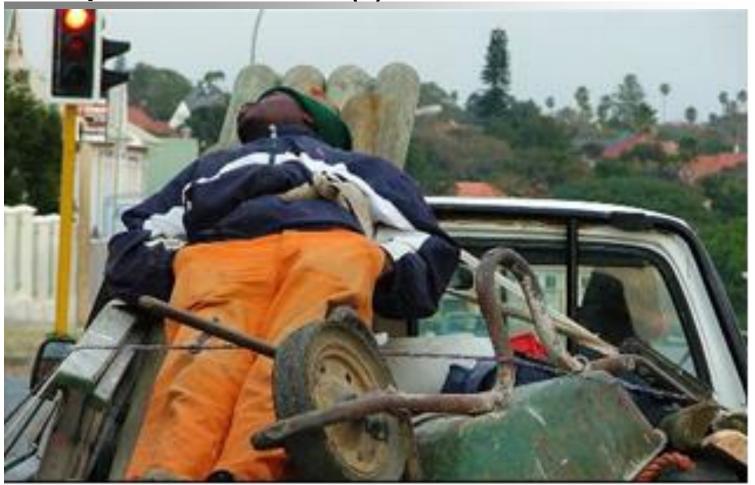
Photo 7: Worker tied down to back of LDV (Mtola in cidb, 2009)

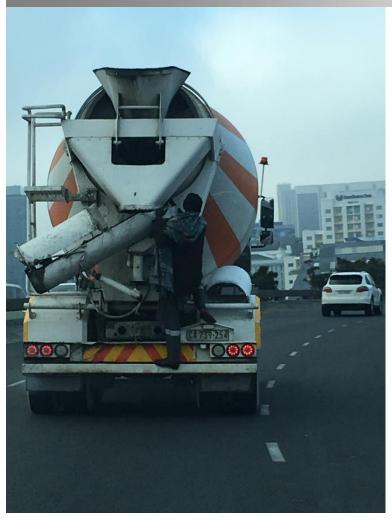
Photo 8: 'Riding' a RMC truck, Cape Town, 14 July 2016 (Anonymous, 2016)

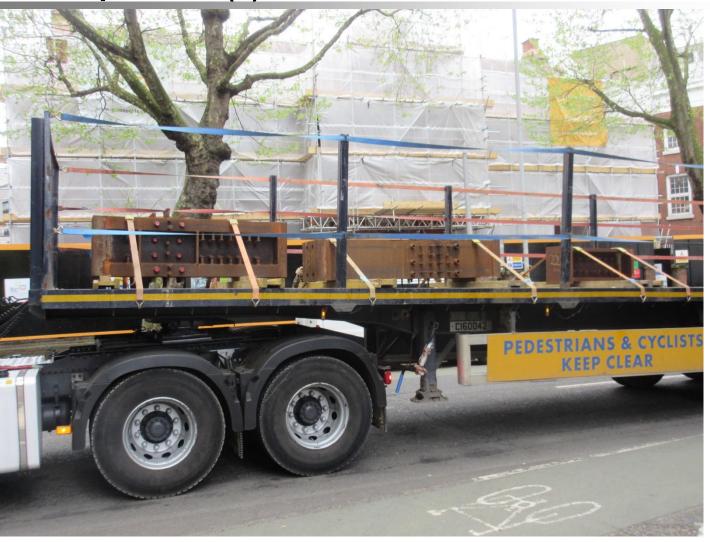
Photo 14: Secured load, London (Smallwood, April 2018)

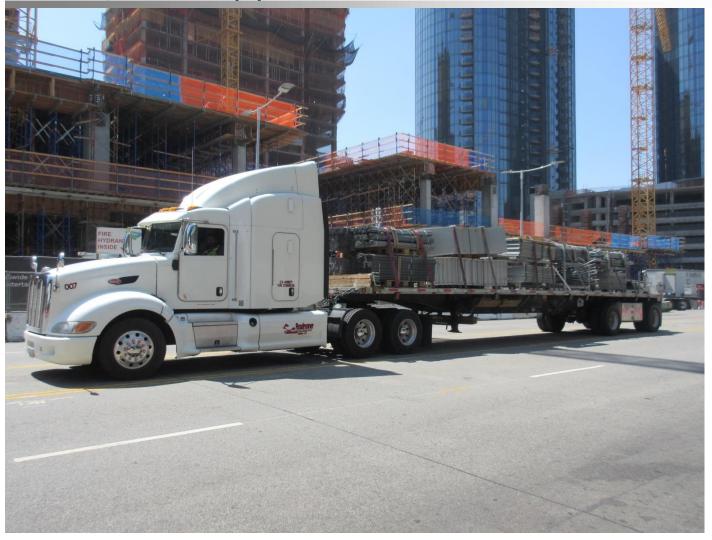
Photo 15: Secured load, Los Angeles (Smallwood, July 2017)

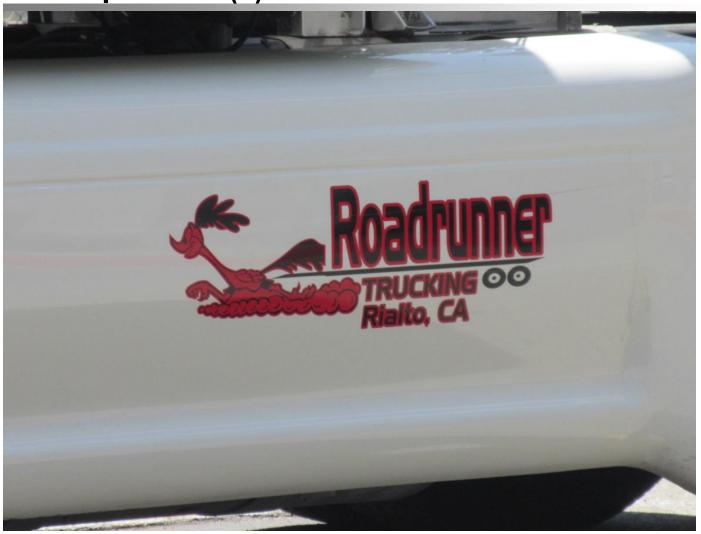
Photo 16: Close up of secured load truck, Los Angeles (Smallwood, July 2017)
